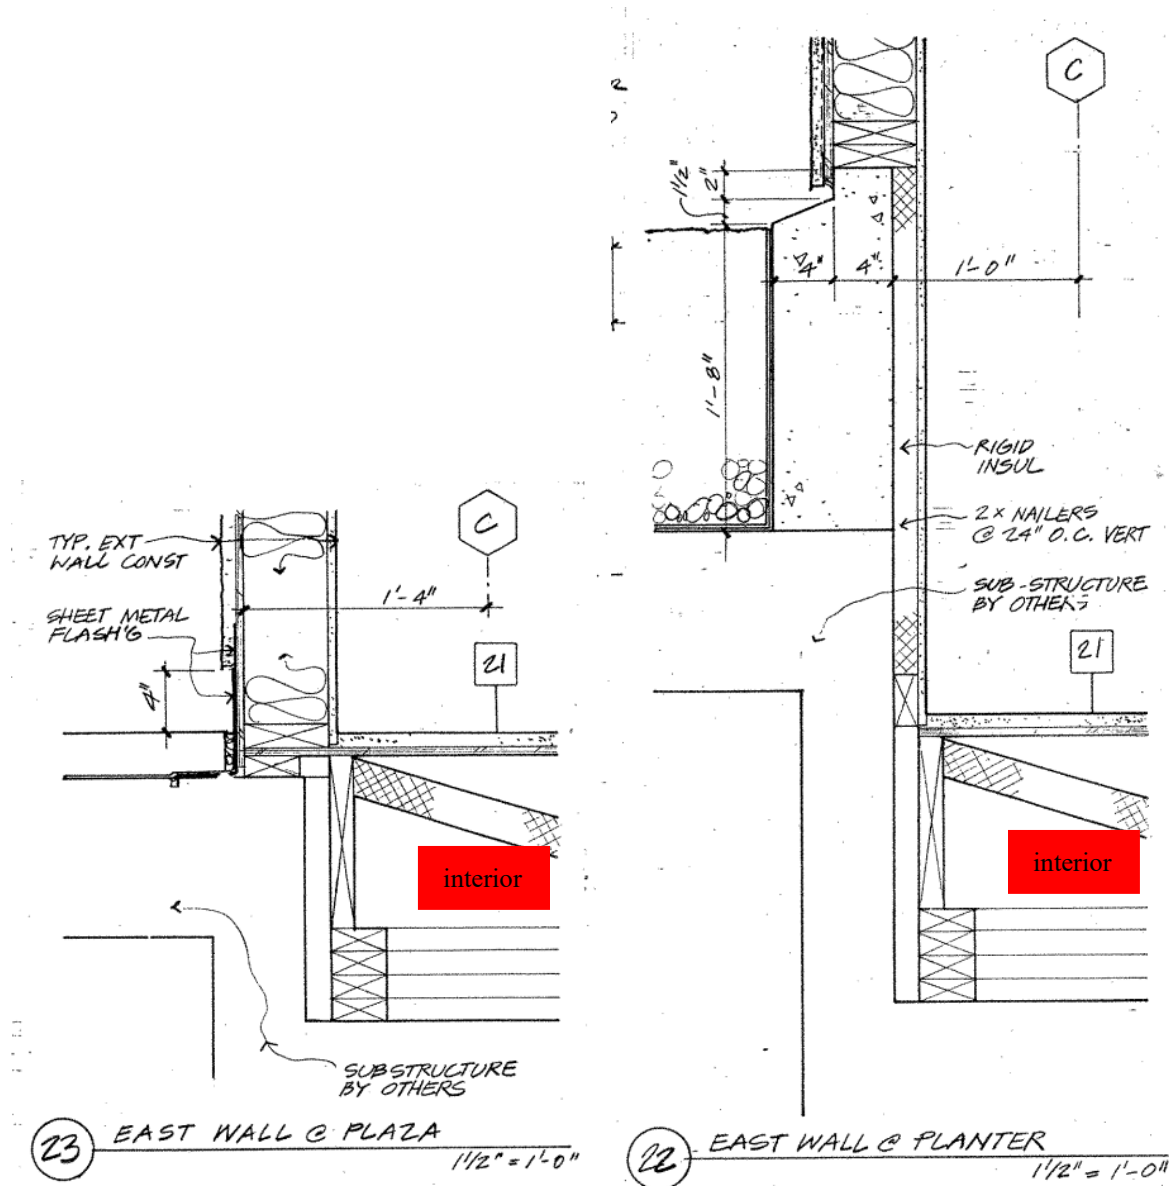
Figure 2. Details on page A8.1 showing a curb for detail 22 and no curb for detail 23. Note: it is unclear where detail 23 is cut through the plaza, as there were no detail bugs found on the plan or section drawings for detail 23.

At the perimeter edges of the plaza, there should be a concrete curb to form a bathtub to turn waterproofing up against. Detail 23 (Figure 2) shows the framed wall extended below the topping slab. This is poor construction practice and will result in deteriorated framing/sheathing once the waterproofing ages and no longer provides protection. This condition appears to be the cause of water under the floor of the Heritage House.

The edge of the slab should be constructed similar to Detail 23 (Figure 2), with a continuous concrete curb placed at the edge. In addition, waterproofing should extend up onto the framed wall and where exposed above topping slab should be covered with stainless steel flashing. See Figure 3, below.

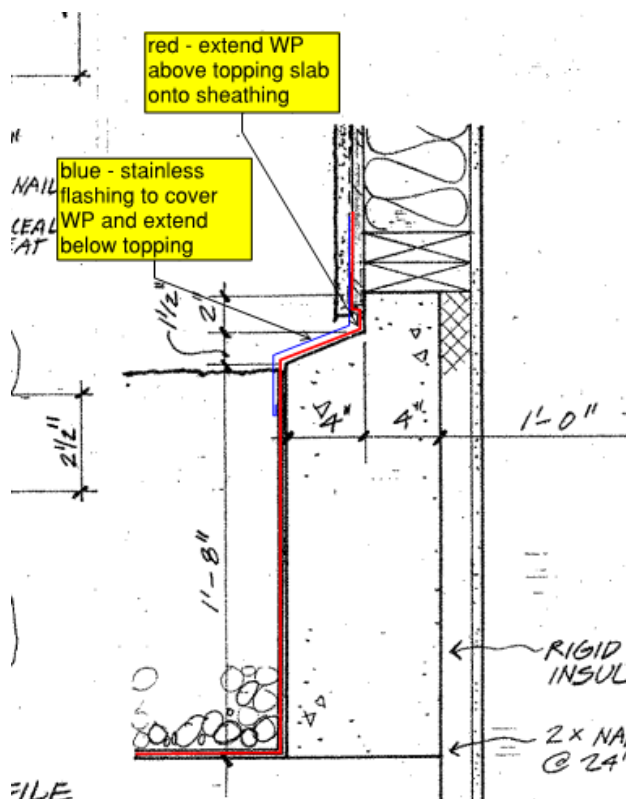
Figure 3. Suggested waterproofing detail showing waterproofing extending above topping slab onto sheathing behind stucco, covered with stainless steel flashing.

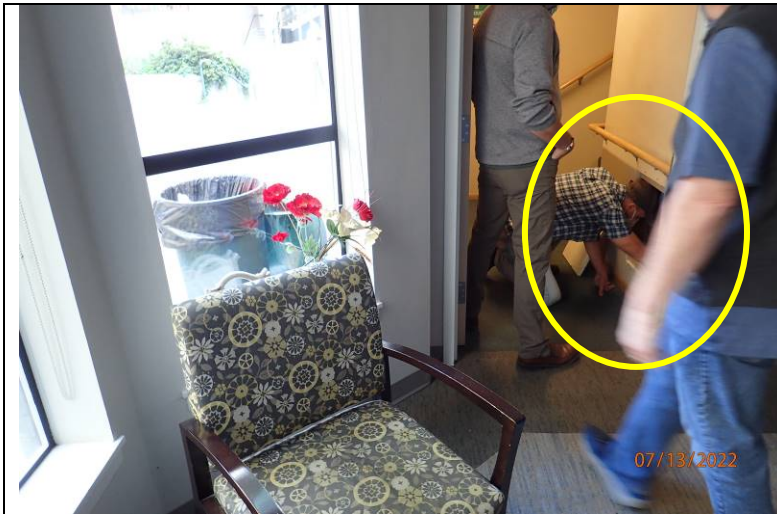
Photograph 7:
Inside the Heritage House, looking
in an access panel that has a cut
out in the floor at Stairwell B

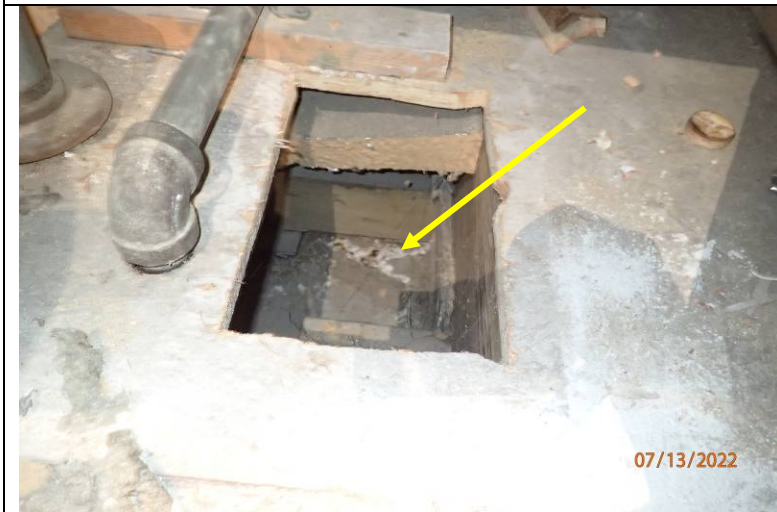
To the west of the trash room there is a stairwell with an access door at the base of a wall. Inside the access door the floor was cut out and water stains were visible on the slab below the wood framing that supports the floor.

Photograph 8:
Looking inside the access area in
Stairwell B. Note the water stains
on the concrete substrate below the
wood framed floor. Water entry
has occurred under the wood
framed flooring on the lid of the
garage below.

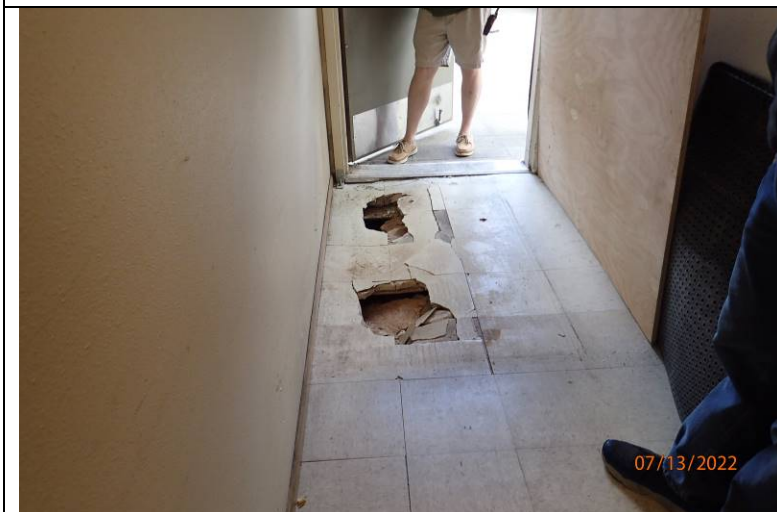
Inside the hallway, to the east side of the trash room (see Figure 1), the floor is damaged reportedly from heavy wheeled carts. It appears the damage may have occurred due to moisture damage to the wood framing and sheathing below the floor cavity as a result of water entry under the floor from the plaza.

Photograph 9:
Looking north at the damaged
floor to the east of Stairwell B.
Reportedly, the floor caved in
when moving heavy carts over the
surface.

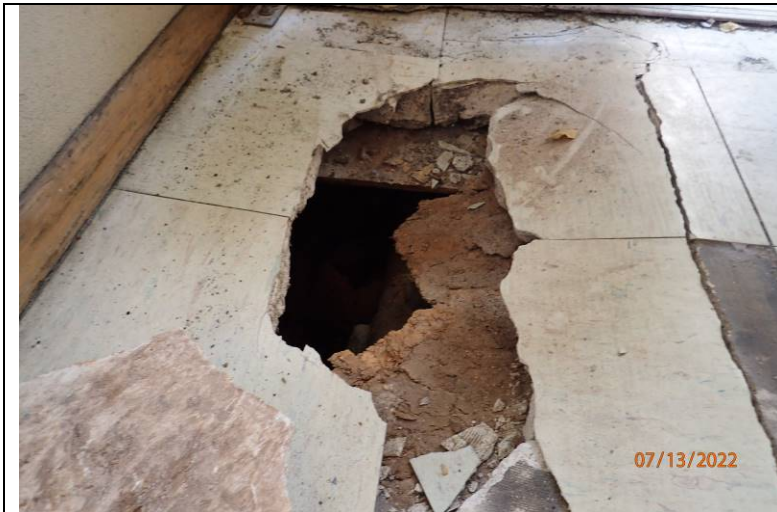
Photograph 10:
Closer view of the damaged floor. It appears the substrate has deteriorated, likely due to moisture within the assembly.

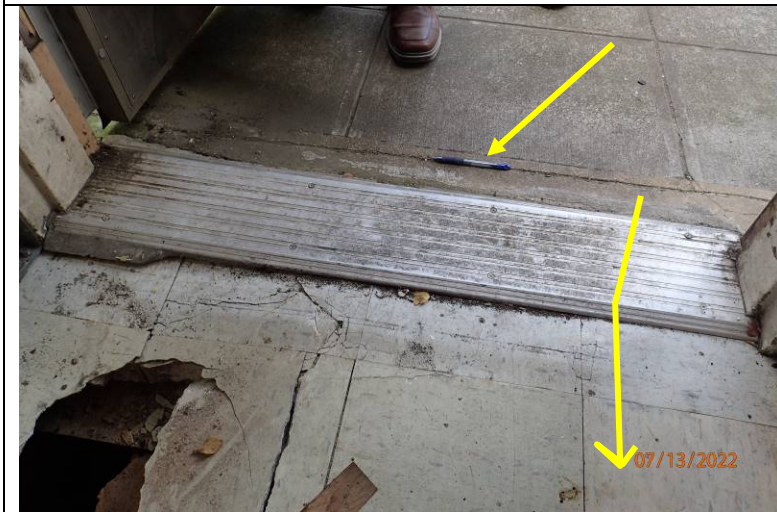
Photograph 11:
Where the pen is placed appears to be the top of a concrete stem wall that separates the plaza from the Heritage House exterior wall. The top of the stem wall is exposed and could allow water under the threshold and into the floor cavity.

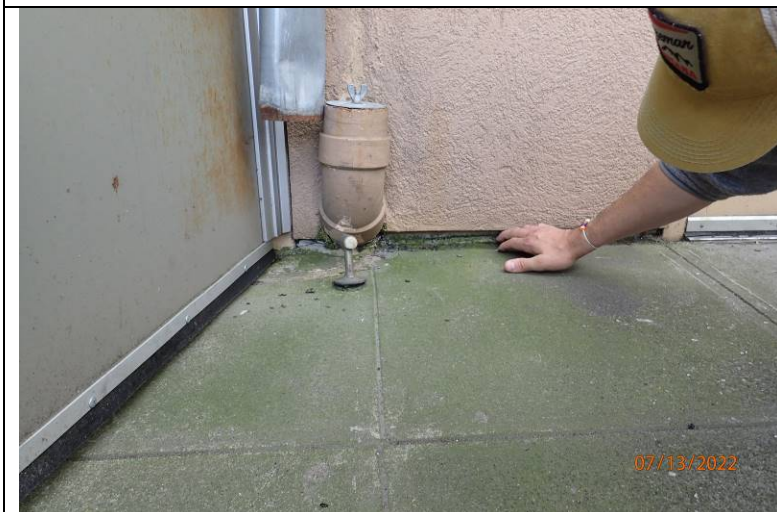
Photograph 12:
Looking at the plaza-to-wall transition outside the hallway in the previous photo, further west. Note the downspouts were disconnected from the below grade drain lines and allowed to discharge onto the plaza, which reportedly has reduced leakage into the garage below.

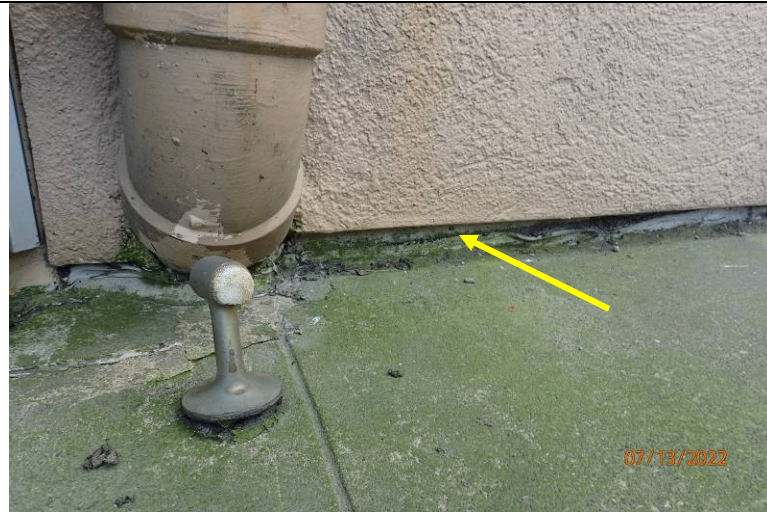
Photograph 13:
Closer view of the previous photo. The substrate below the stucco and above the plaza topping slab appears to be sheathing covered with metal, and not concrete.

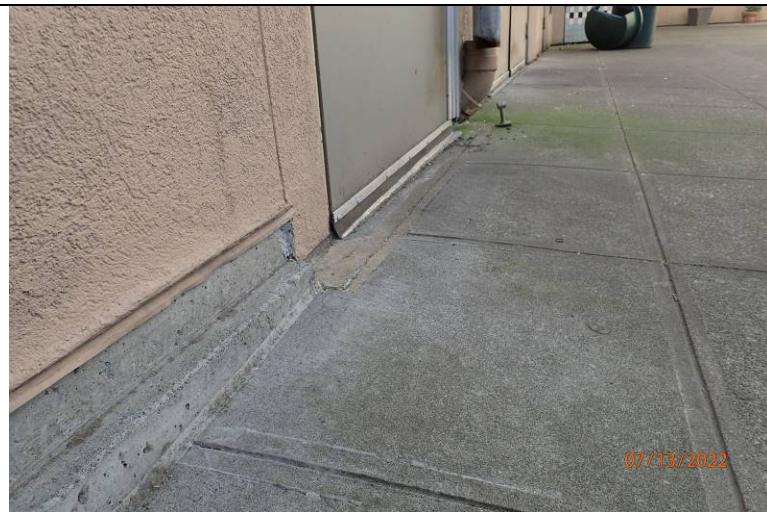
Photograph 14:
Looking west along the north wall of the Heritage House. The door in the photo is to the hallway in photos 10 & 11. Note the concrete curb in the left of the photo, which is not present west of the door.

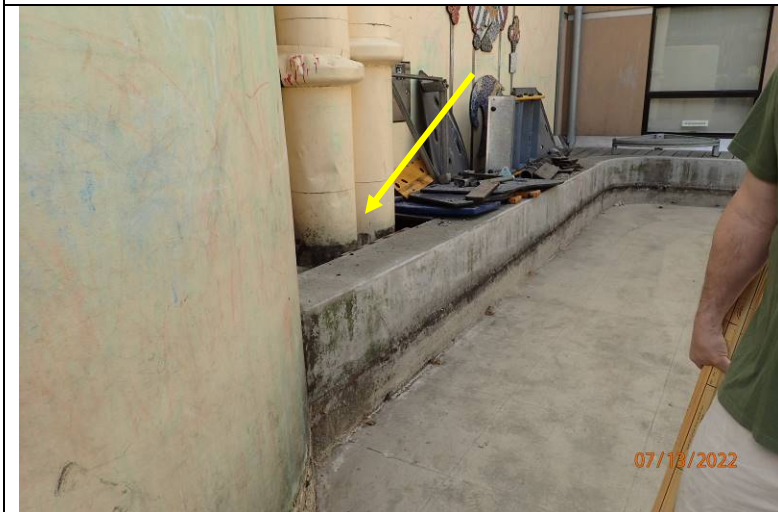
At the north side of the stairs in the center of the plaza, and adjacent elevators, there is a concrete wall that appears to have been placed over the topping slab. This wall has weeps underneath, which SSI reported were clogged when the overburden was removed to expose the base of the wall. The wall creates a “bathtub” area that holds water from rainfall. Within the bathtub area

Photograph 17:
The curb in the photo is over the plaza topping slab, it appears, and has weeps at the bottom. The weeps were reportedly clogged and water becomes trapped on the south side of the concrete curb (arrow). Weeps should be cleaned and maintained so they remain open to drain.

1. Clean out the weeps at the base of the wall and enlarge them so they are easier to maintain.
2. Seal the chiller line penetrations through the topping slab with a liquid applied waterproofing, such as Tremco 250GC with reinforcing. The waterproofing should seal to the pipes and not the insulation. Remove insulation as necessary and reinstall.

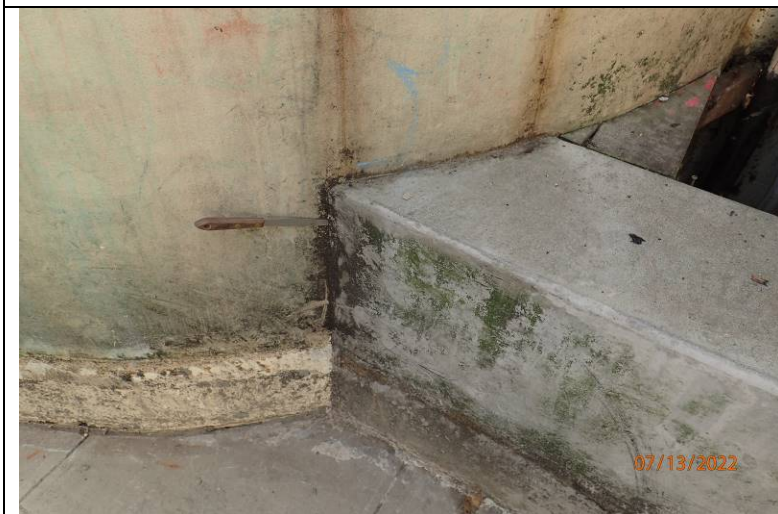
Photograph 18:
Sealant knife inserted into open joint between the curb and round structure at the stairs. This joint should be sealed.

3. Seal the joint at the ends of the concrete wall where it abuts the stairwell wall.
4. Install a row of drainage mat to the north side of the concrete wall and stairwell as part of the work the SSI is performing. The drain mat would be installed below the new playground surfacing and help promote drainage away from the area, as well as help keep the exterior sides of the weep holes open. The drain mat should be turned up the vertical surface at least 4", or just below the height of the playground surfacing. Filter fabric should be integral, or installed, wrapping the top of the drainage mat to prevent debris from migrating into the matrix of the mat.

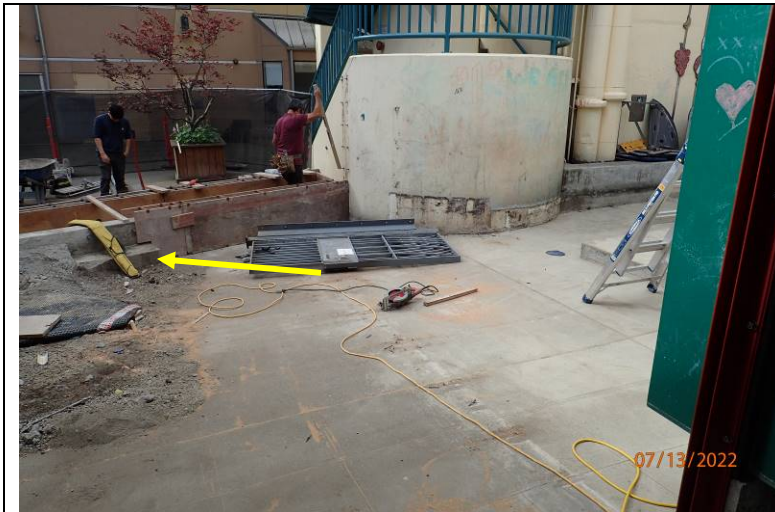
Photograph 19:
Looking south at the north end of the plaza and area of work by SSI. The slope of the plaza is to the left (east) and through drainage mat that travels under the concrete stem wall. The drainage mat will be restored and installed under the new finishes over the topping slab visible in this photo. Arrow shows direction of water flow.

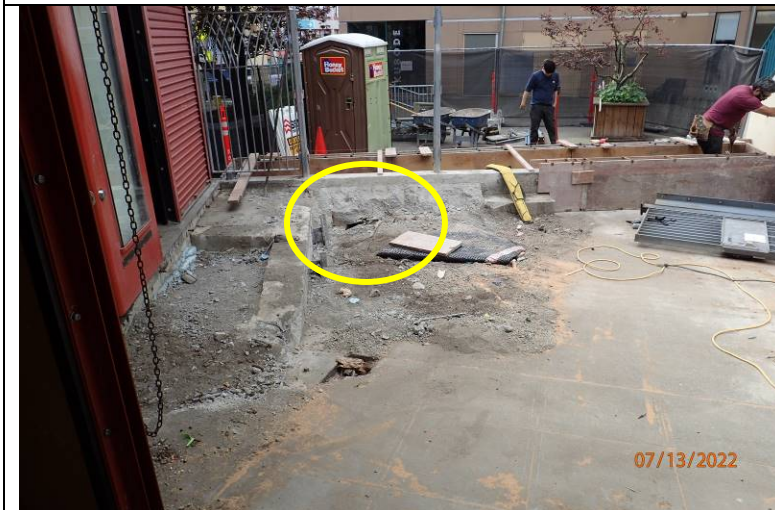
Photograph 20:
Looking south at the concrete stem wall and existing drain mat (circled) found that travels under the wall.

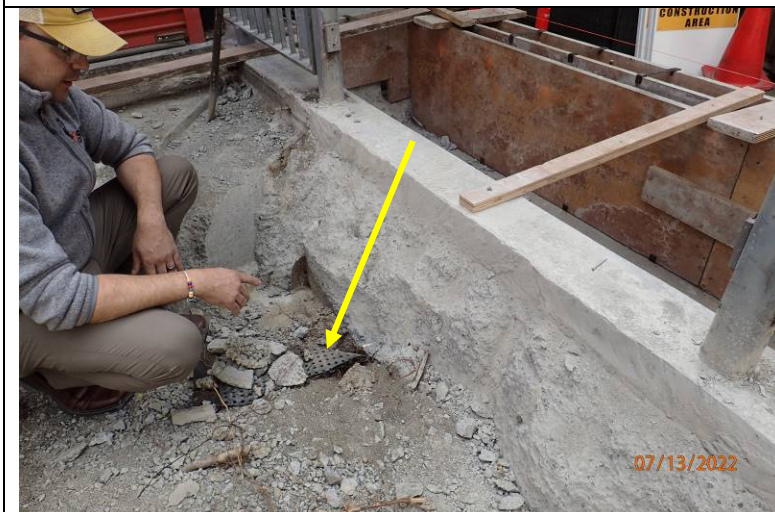
Photograph 21:
Closer view showing the drain mat. We understand this wall will be removed to allow new drain mat installation.

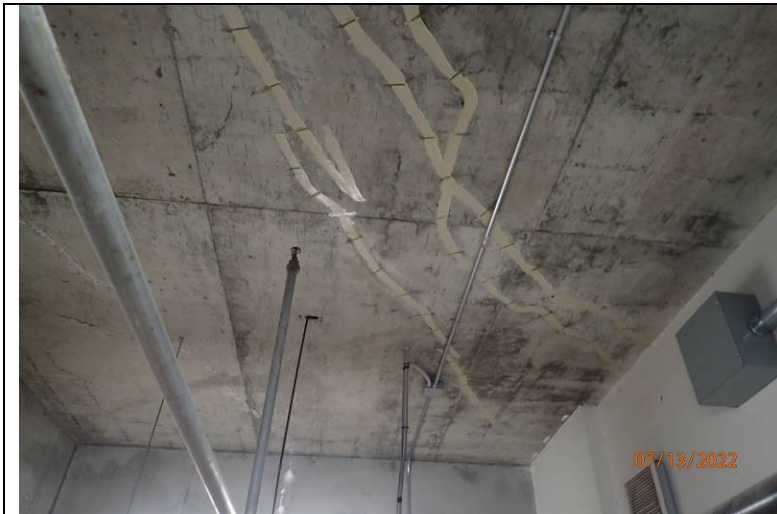
There is evidence of what appears to be epoxy injection in the ceiling of the food bank.

Photograph 22:
Injection performed in the ceiling
of the food bank.

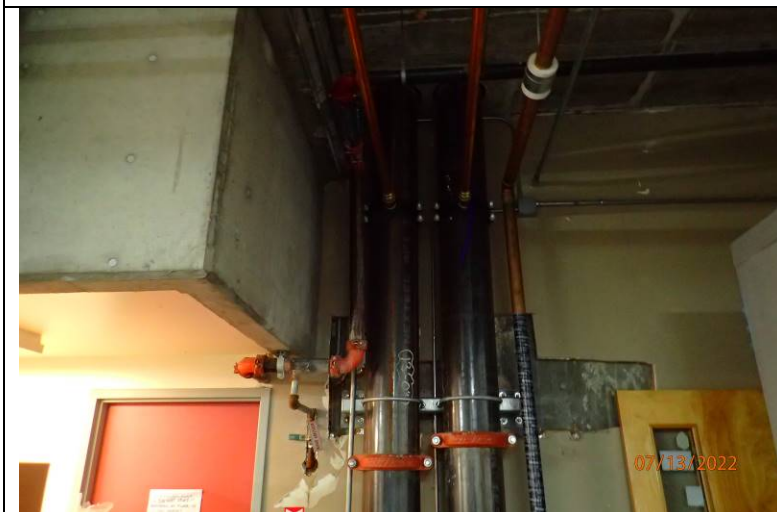
there are large chiller lines that penetrate the topping slab and structural slab and continue into the basement below. Water reportedly leaks around these chiller line penetrations during periods of rainfall.

Photograph 24:
Chiller lines within the
garage/food bank space, below the
north side of the elevators.

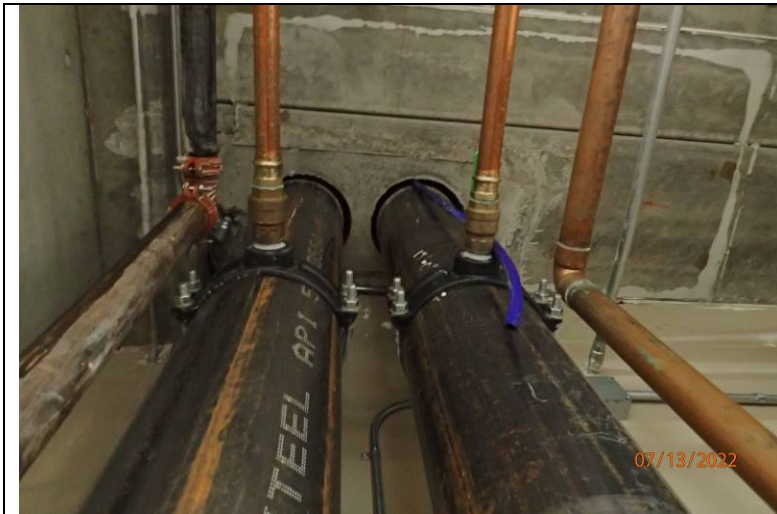
Photograph 25:
Closer view of the chiller line
penetrations through the concrete.
