# FACILITY CONDITION ASSESSMENT & ENERGY AUDIT

## **Providence Health & Services**

Providence Heritage House at the Market  
1533 Western Avenue  
Seattle, Washington 98101

*July 17, 2021*

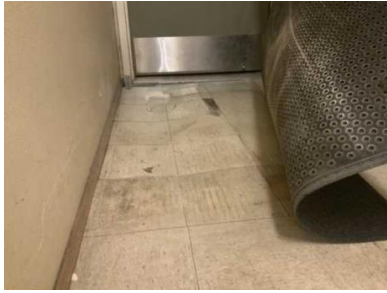
### Structural Flooring in Poor condition.

Concrete  
Providence Heritage House at the Market  
Kitchen hallway

The floor is sunken. - AssetCALC ID: 3042973

Uniformat Code: B1012  
Recommendation: **Repair in 2021**

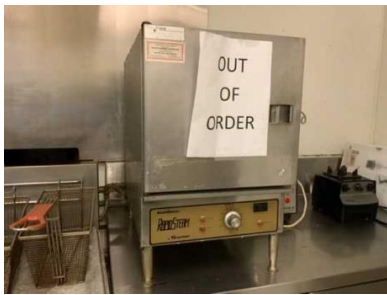
### Foodservice Equipment in Failed condition.

Steamer, Tabletop  
Providence Heritage House at the Market  
Kitchen

Uniformat Code: E1038  
Recommendation: **Replace in 2021**

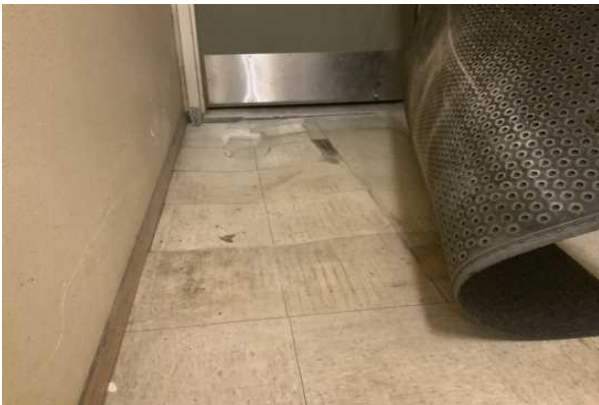
The hallway behind the kitchen has a dip in the floor by the exit. The floor seems to have caved in and needs to be repaired. The roofing has been replaced since construction and the façade has been maintained regularly by the property owner. The common area interior finishes are replaced as needed over the years and the resident units are updated upon turn over.

27	DAMAGED FLOORING
----	------------------
